# Walk Around

## Focke-Wulf Fw 190A/F

Walk Around Number 22  
squadron/signal publications

By Malcolm Laing and E. Brown Ryle

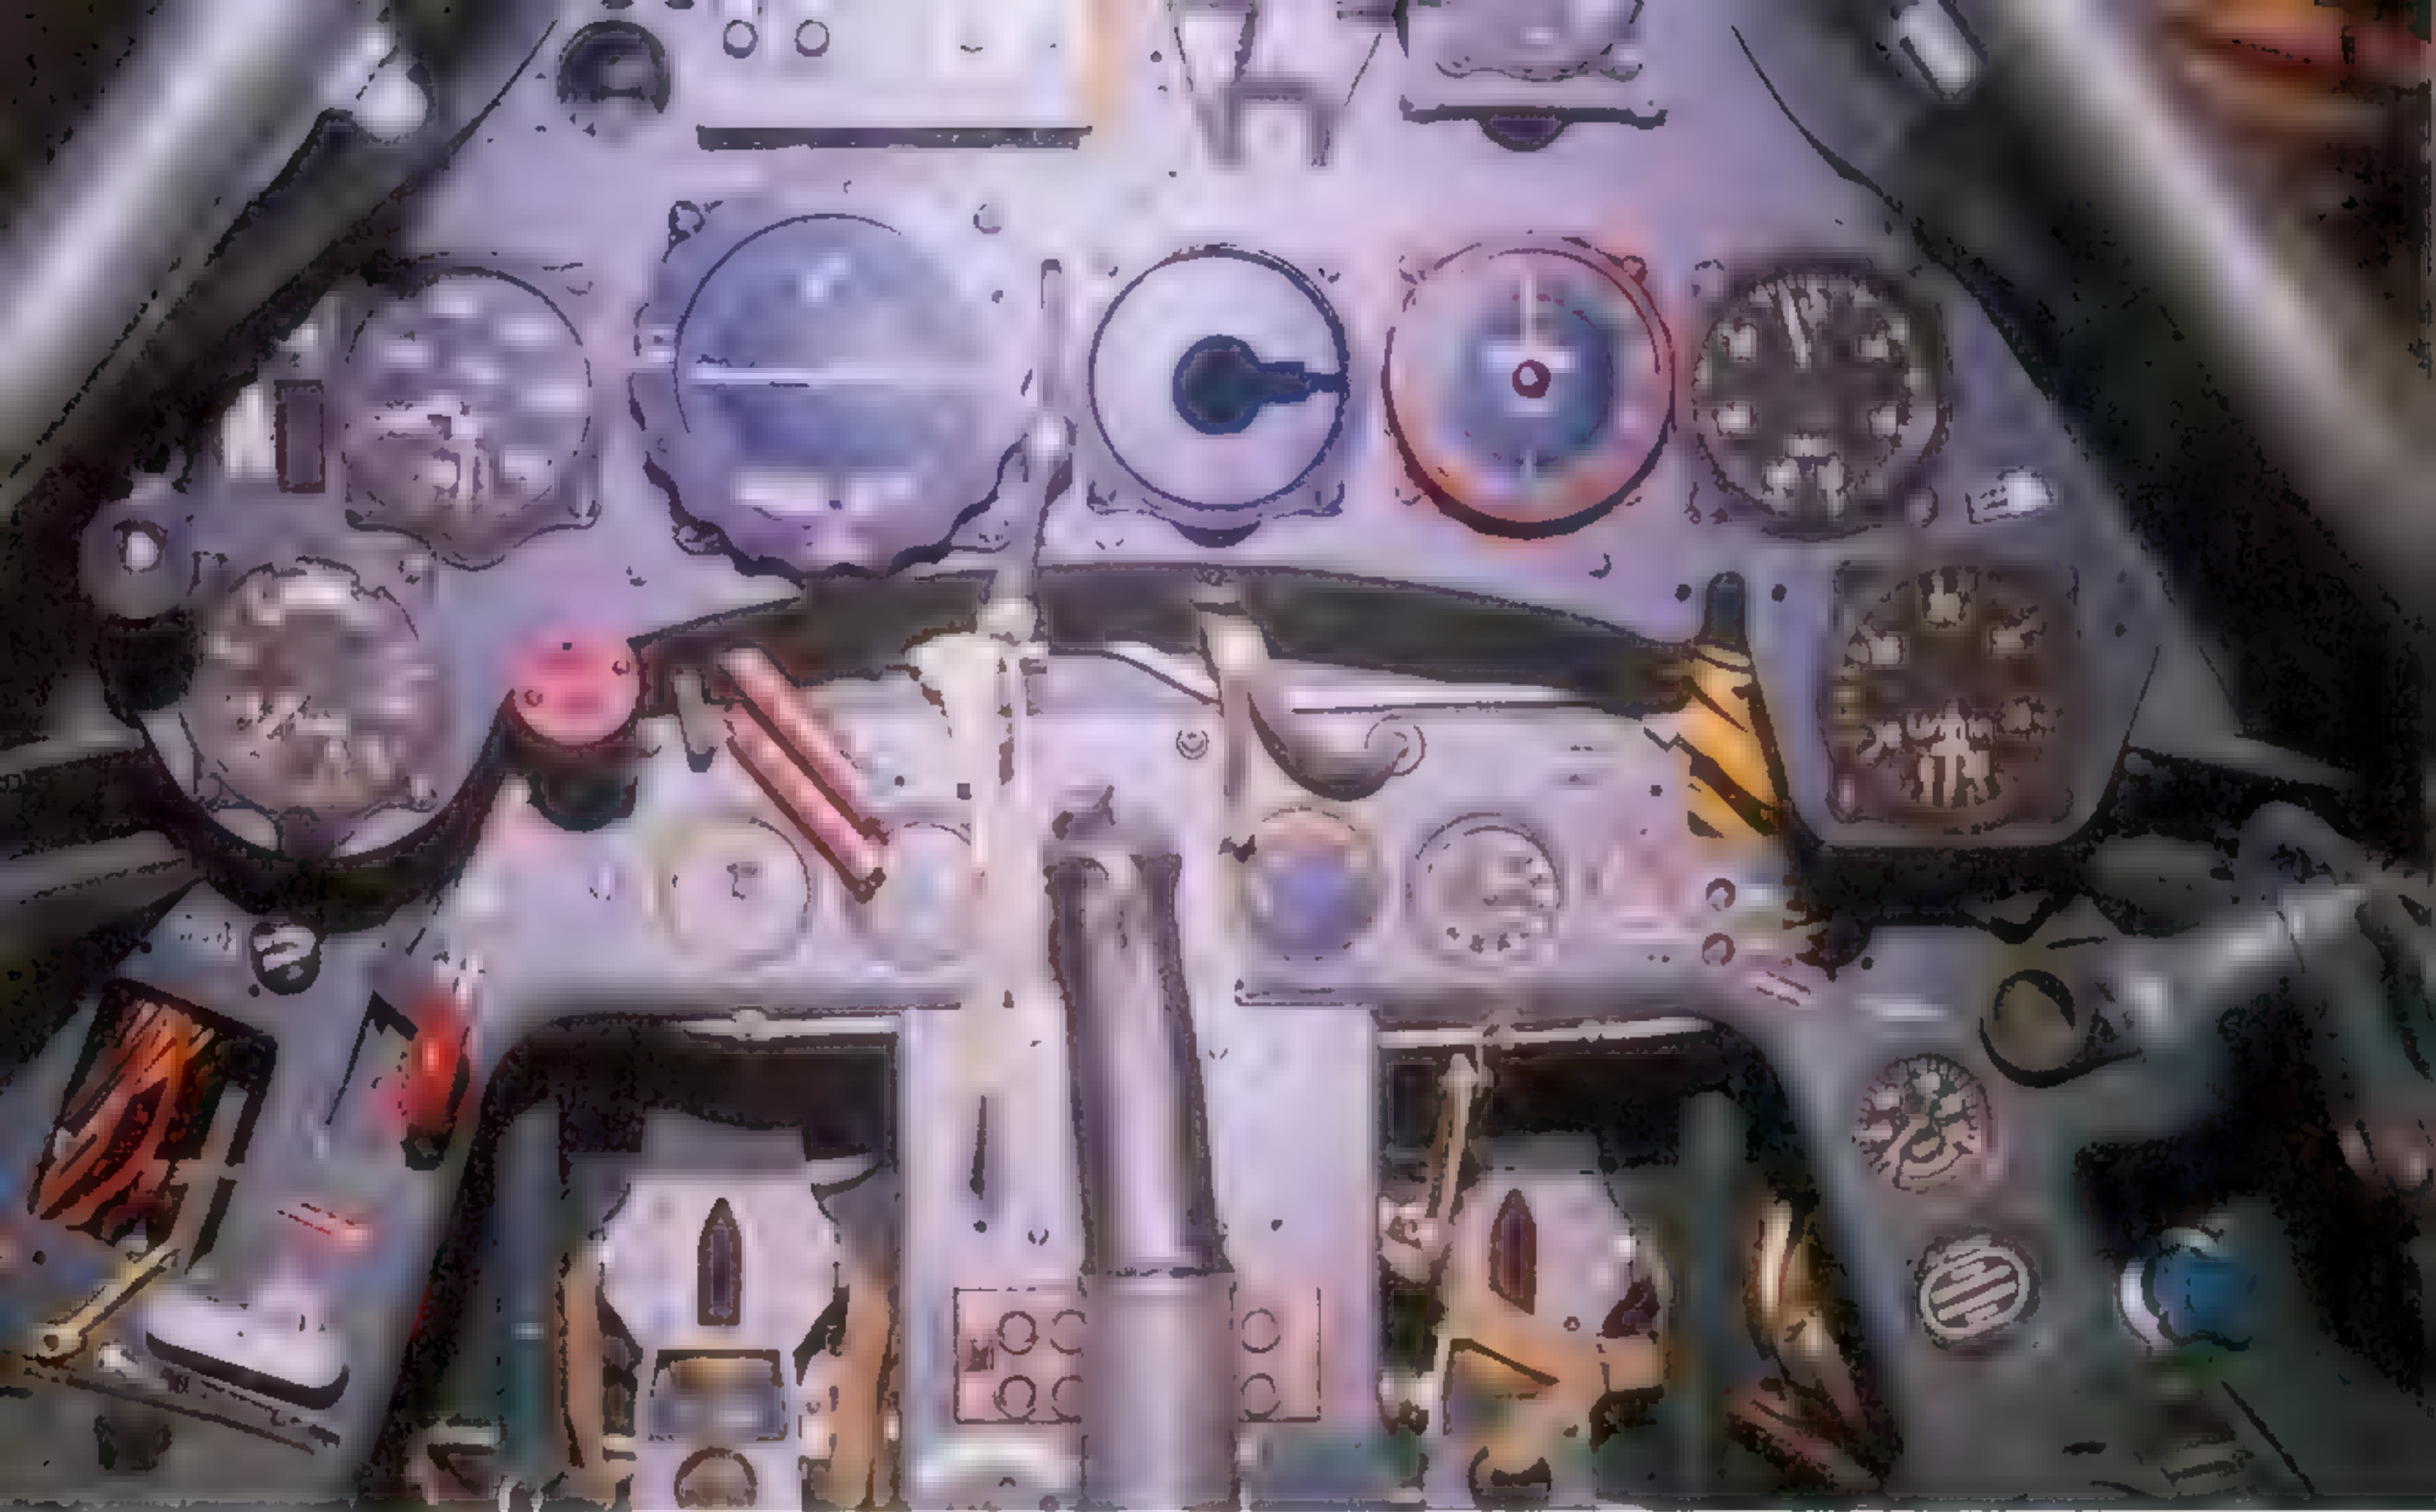
The lower section of the Fw 190F-8's instrument panel houses auxiliary instruments. These instruments are (L-R): Engine starter brushes withdrawal button; fuel tank selector switch; fuel and oil pressure; oil temperature; fuel gauge; propeller pitch; fuel low level light; rear (fuel) tank switch-over light; fuel gauge selector switch; flare gun port; oxygen pressure gauge; oxygen flow gauge; and oxygen flow valve. (Ryle)

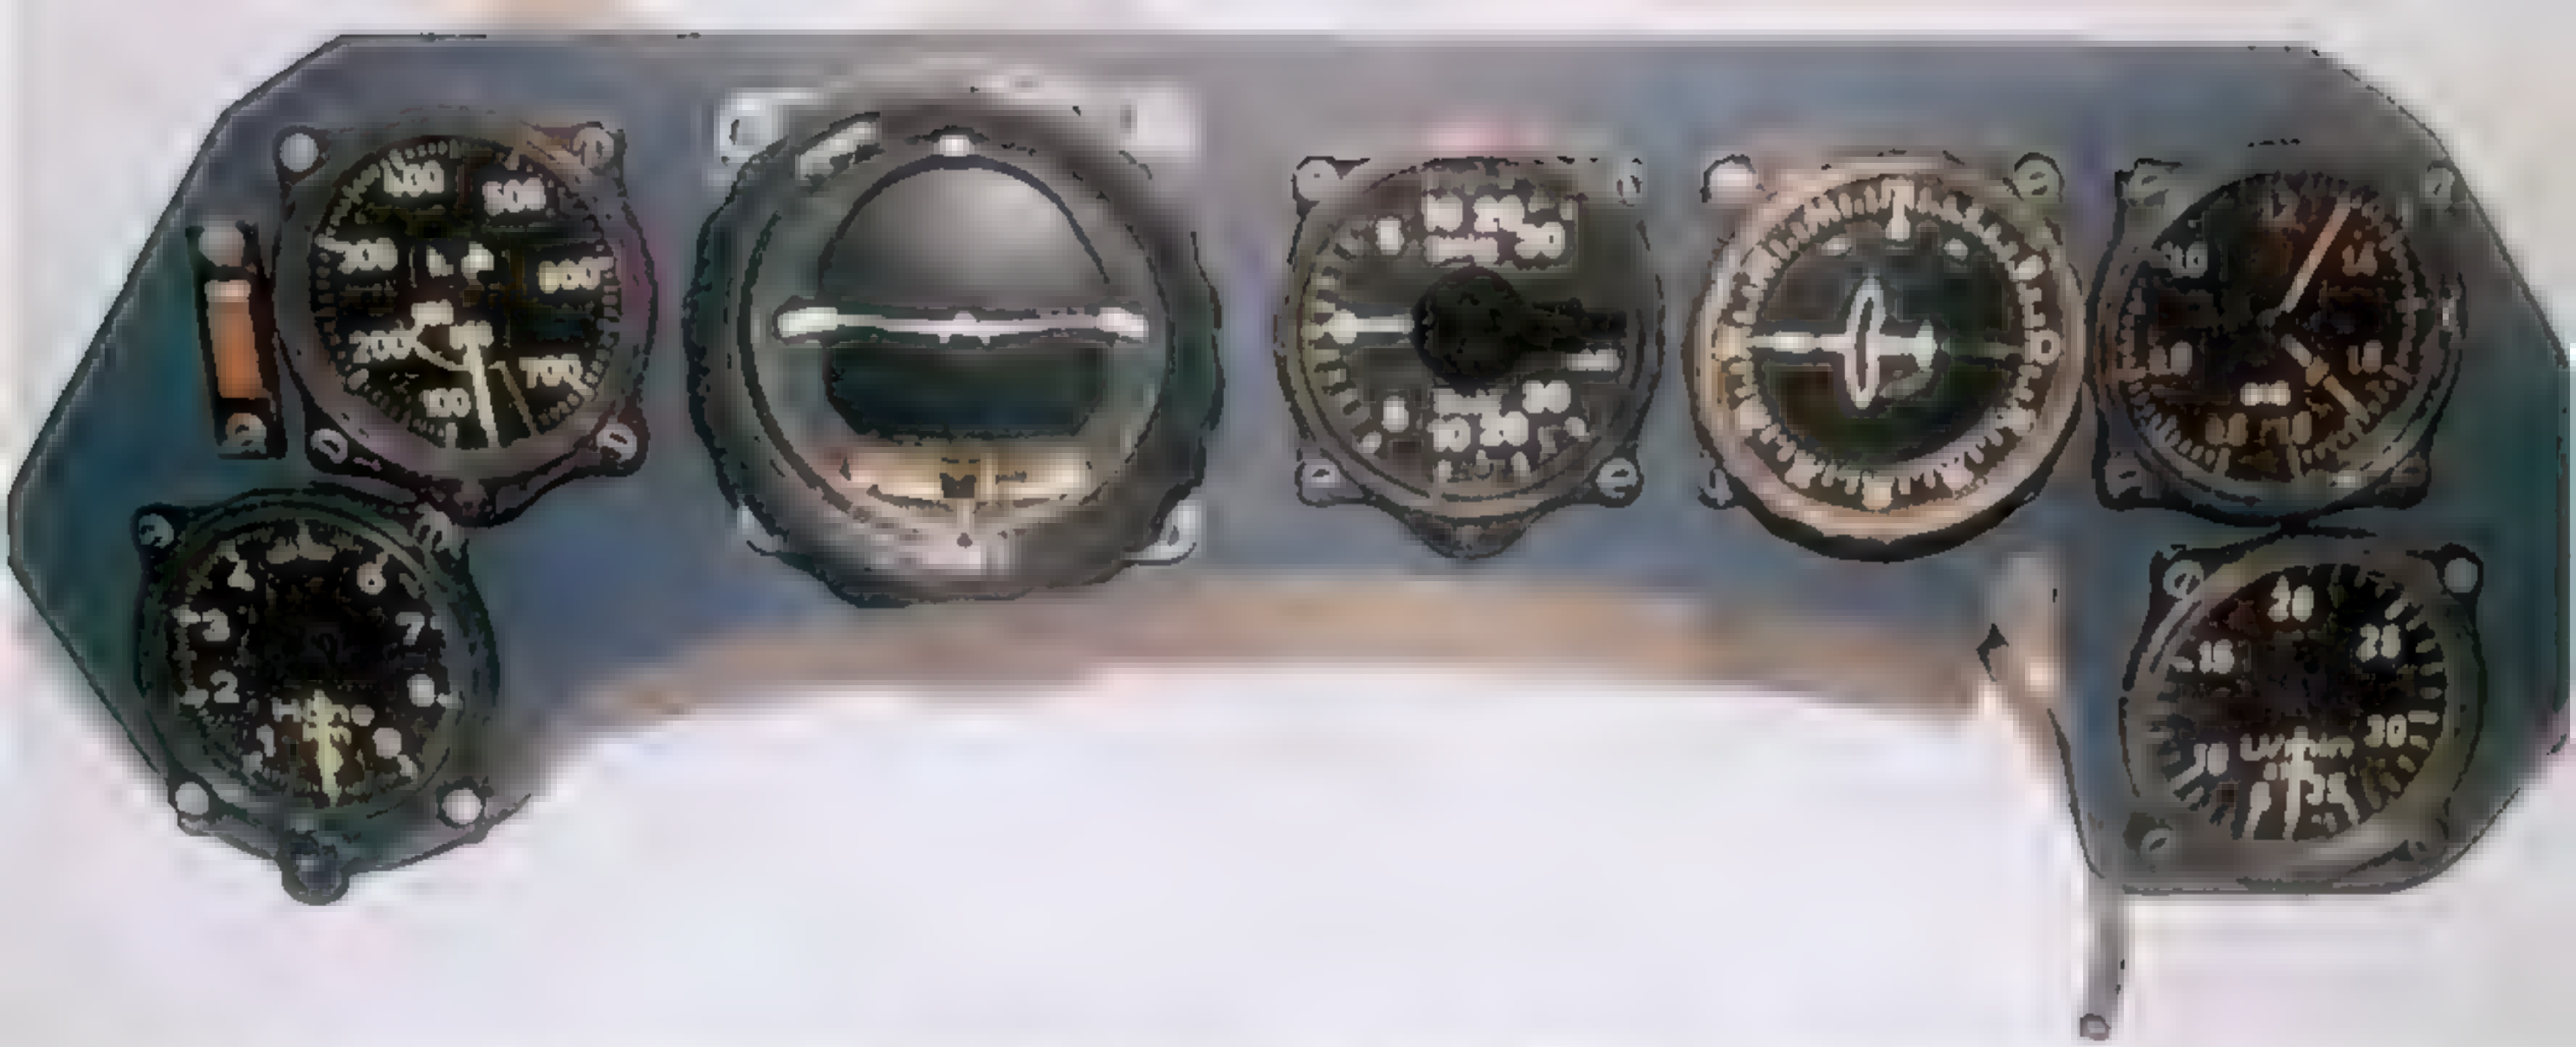
This Fw 190 main instrument panel is painted RLM 66 Black Gray and the instruments are black with white markings. These instruments are (from Left): Pressure altimeter; pitot tube heater light; airspeed indicator; artificial horizon; vertical speed indicator; repeater

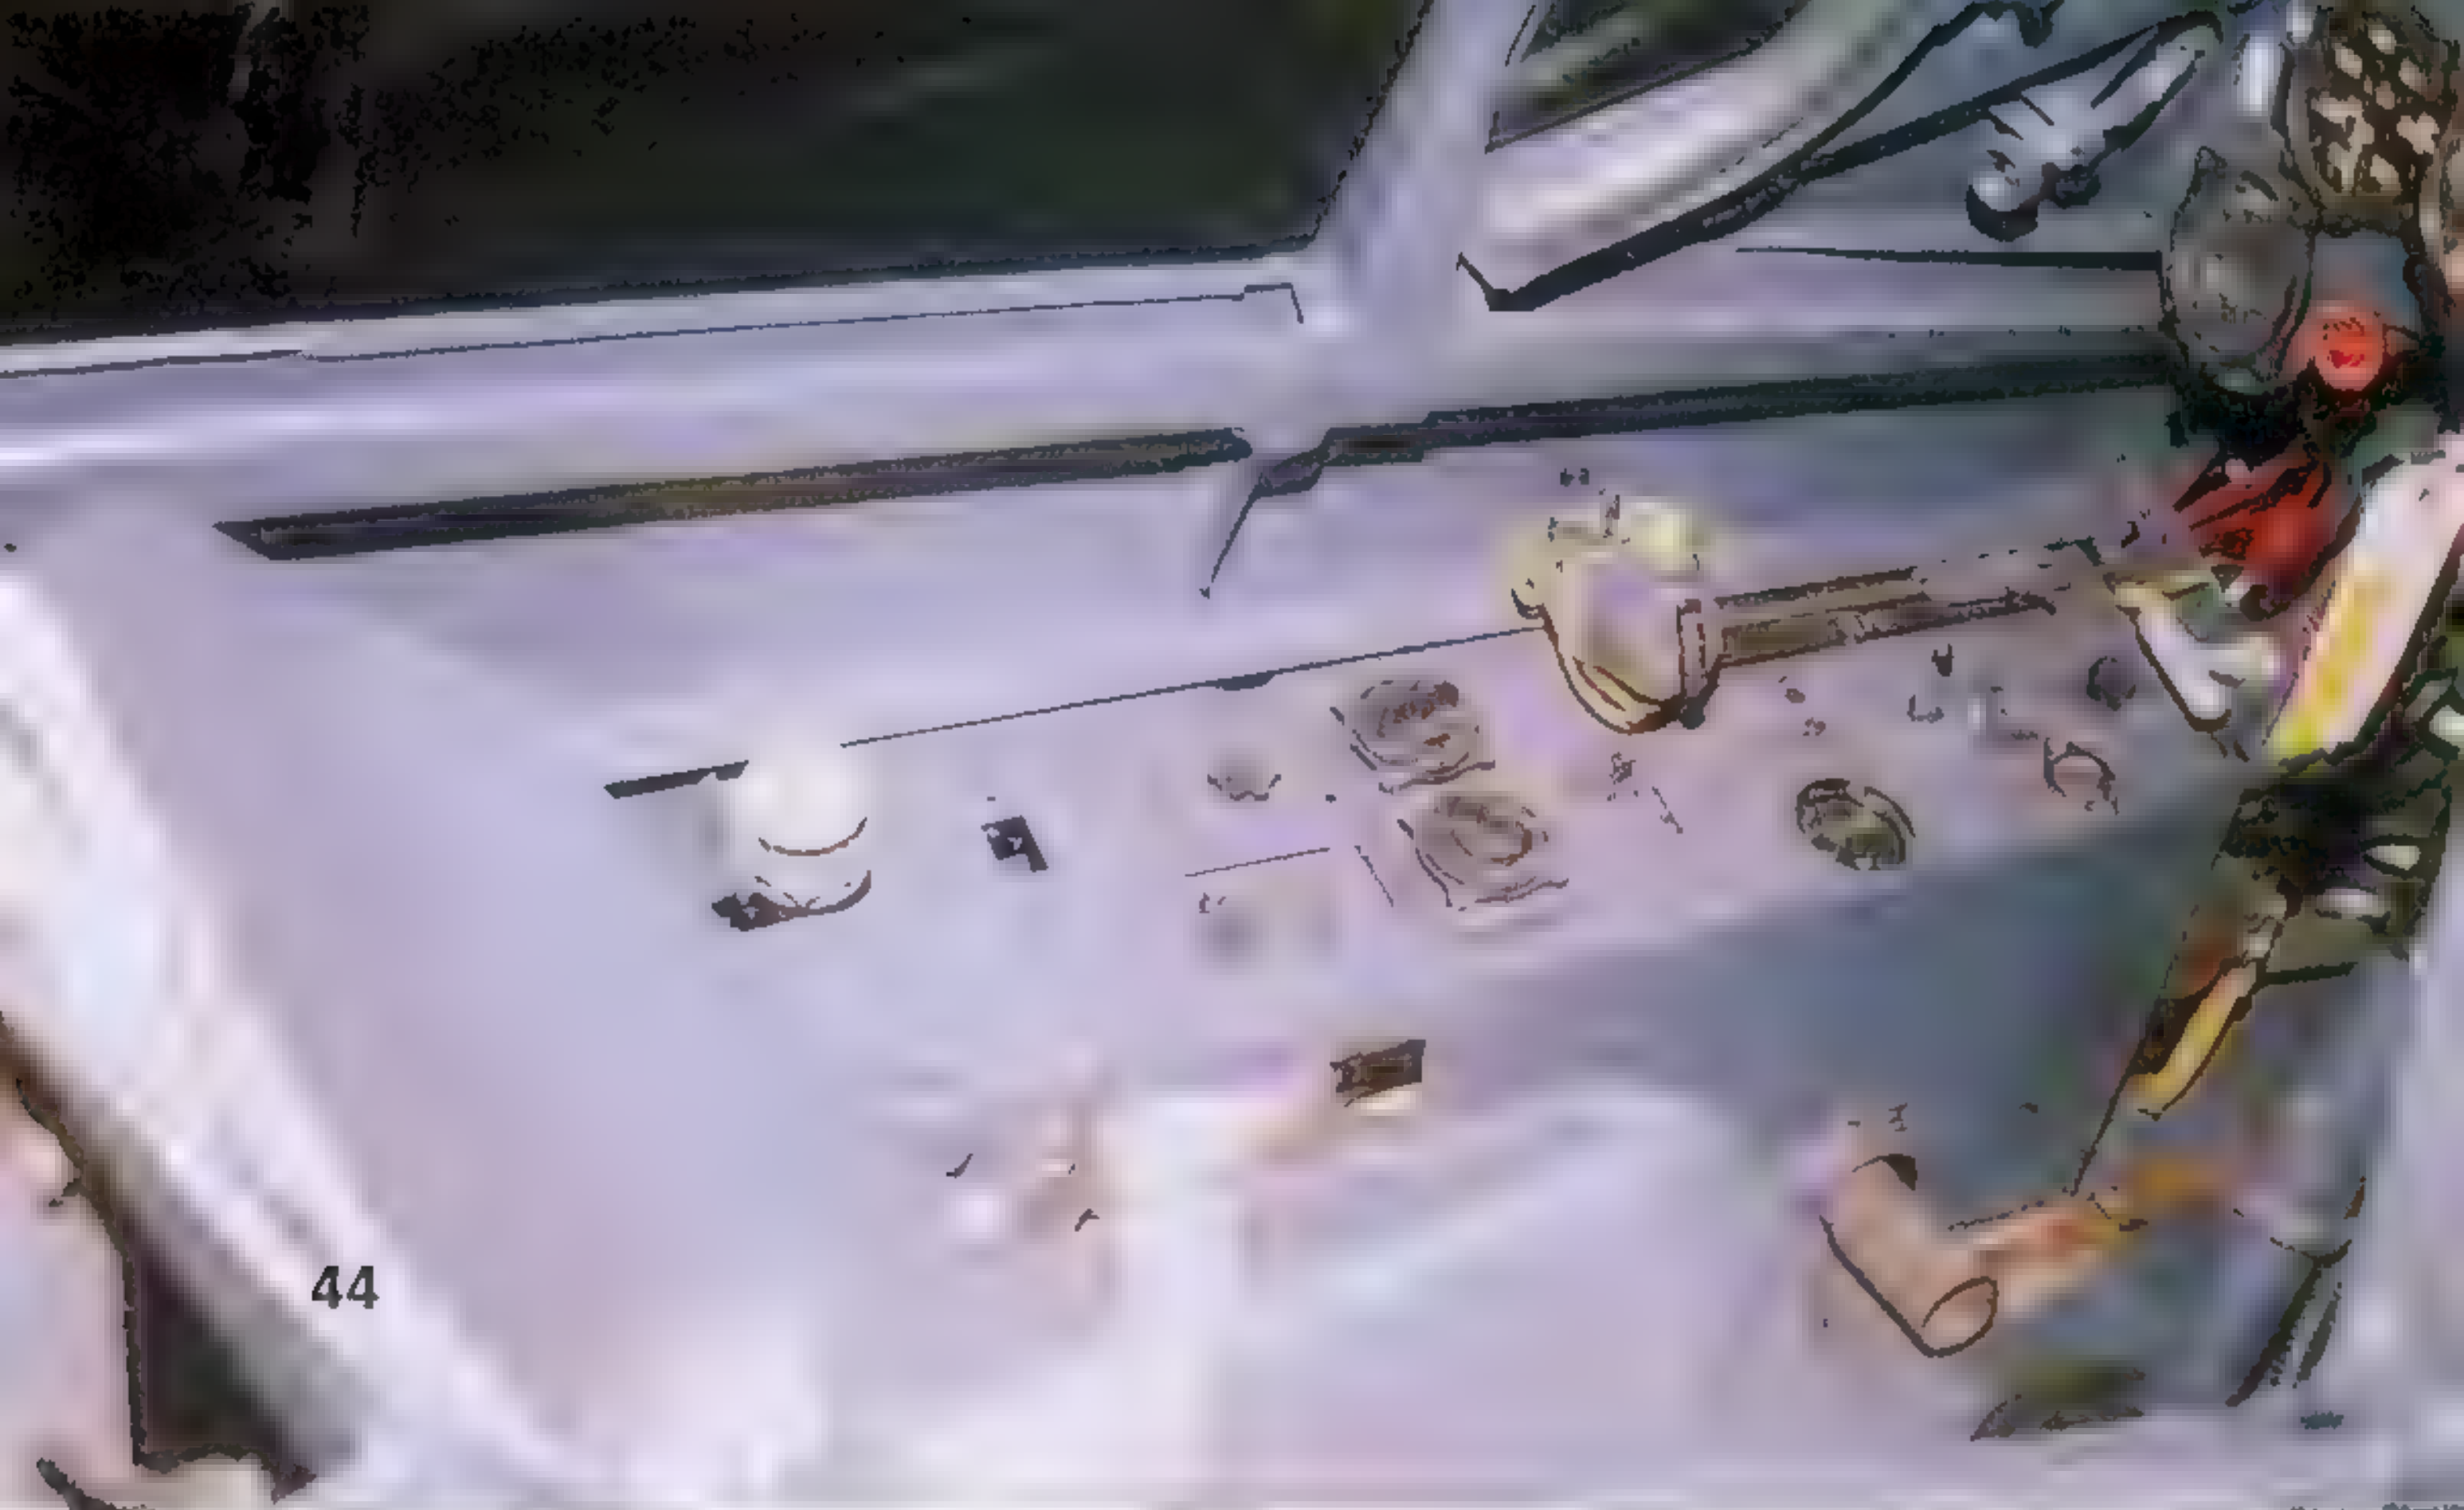
Alongside the pilot's seat in the Fw 190F-8 cockpit is the port console. Console components are (from Aft): Primer fuel pump handle; FuG 16ZY radio volume control; radio tuner; frequency selector; horizontal stabilizer trim switch; landing gear and flap actuator buttons; throttle lever with thumb actuated propeller pitch control; horizontal stabilizer trim indicator; magneto switch; and instrument panel lighting dimmer control. (Ryle)

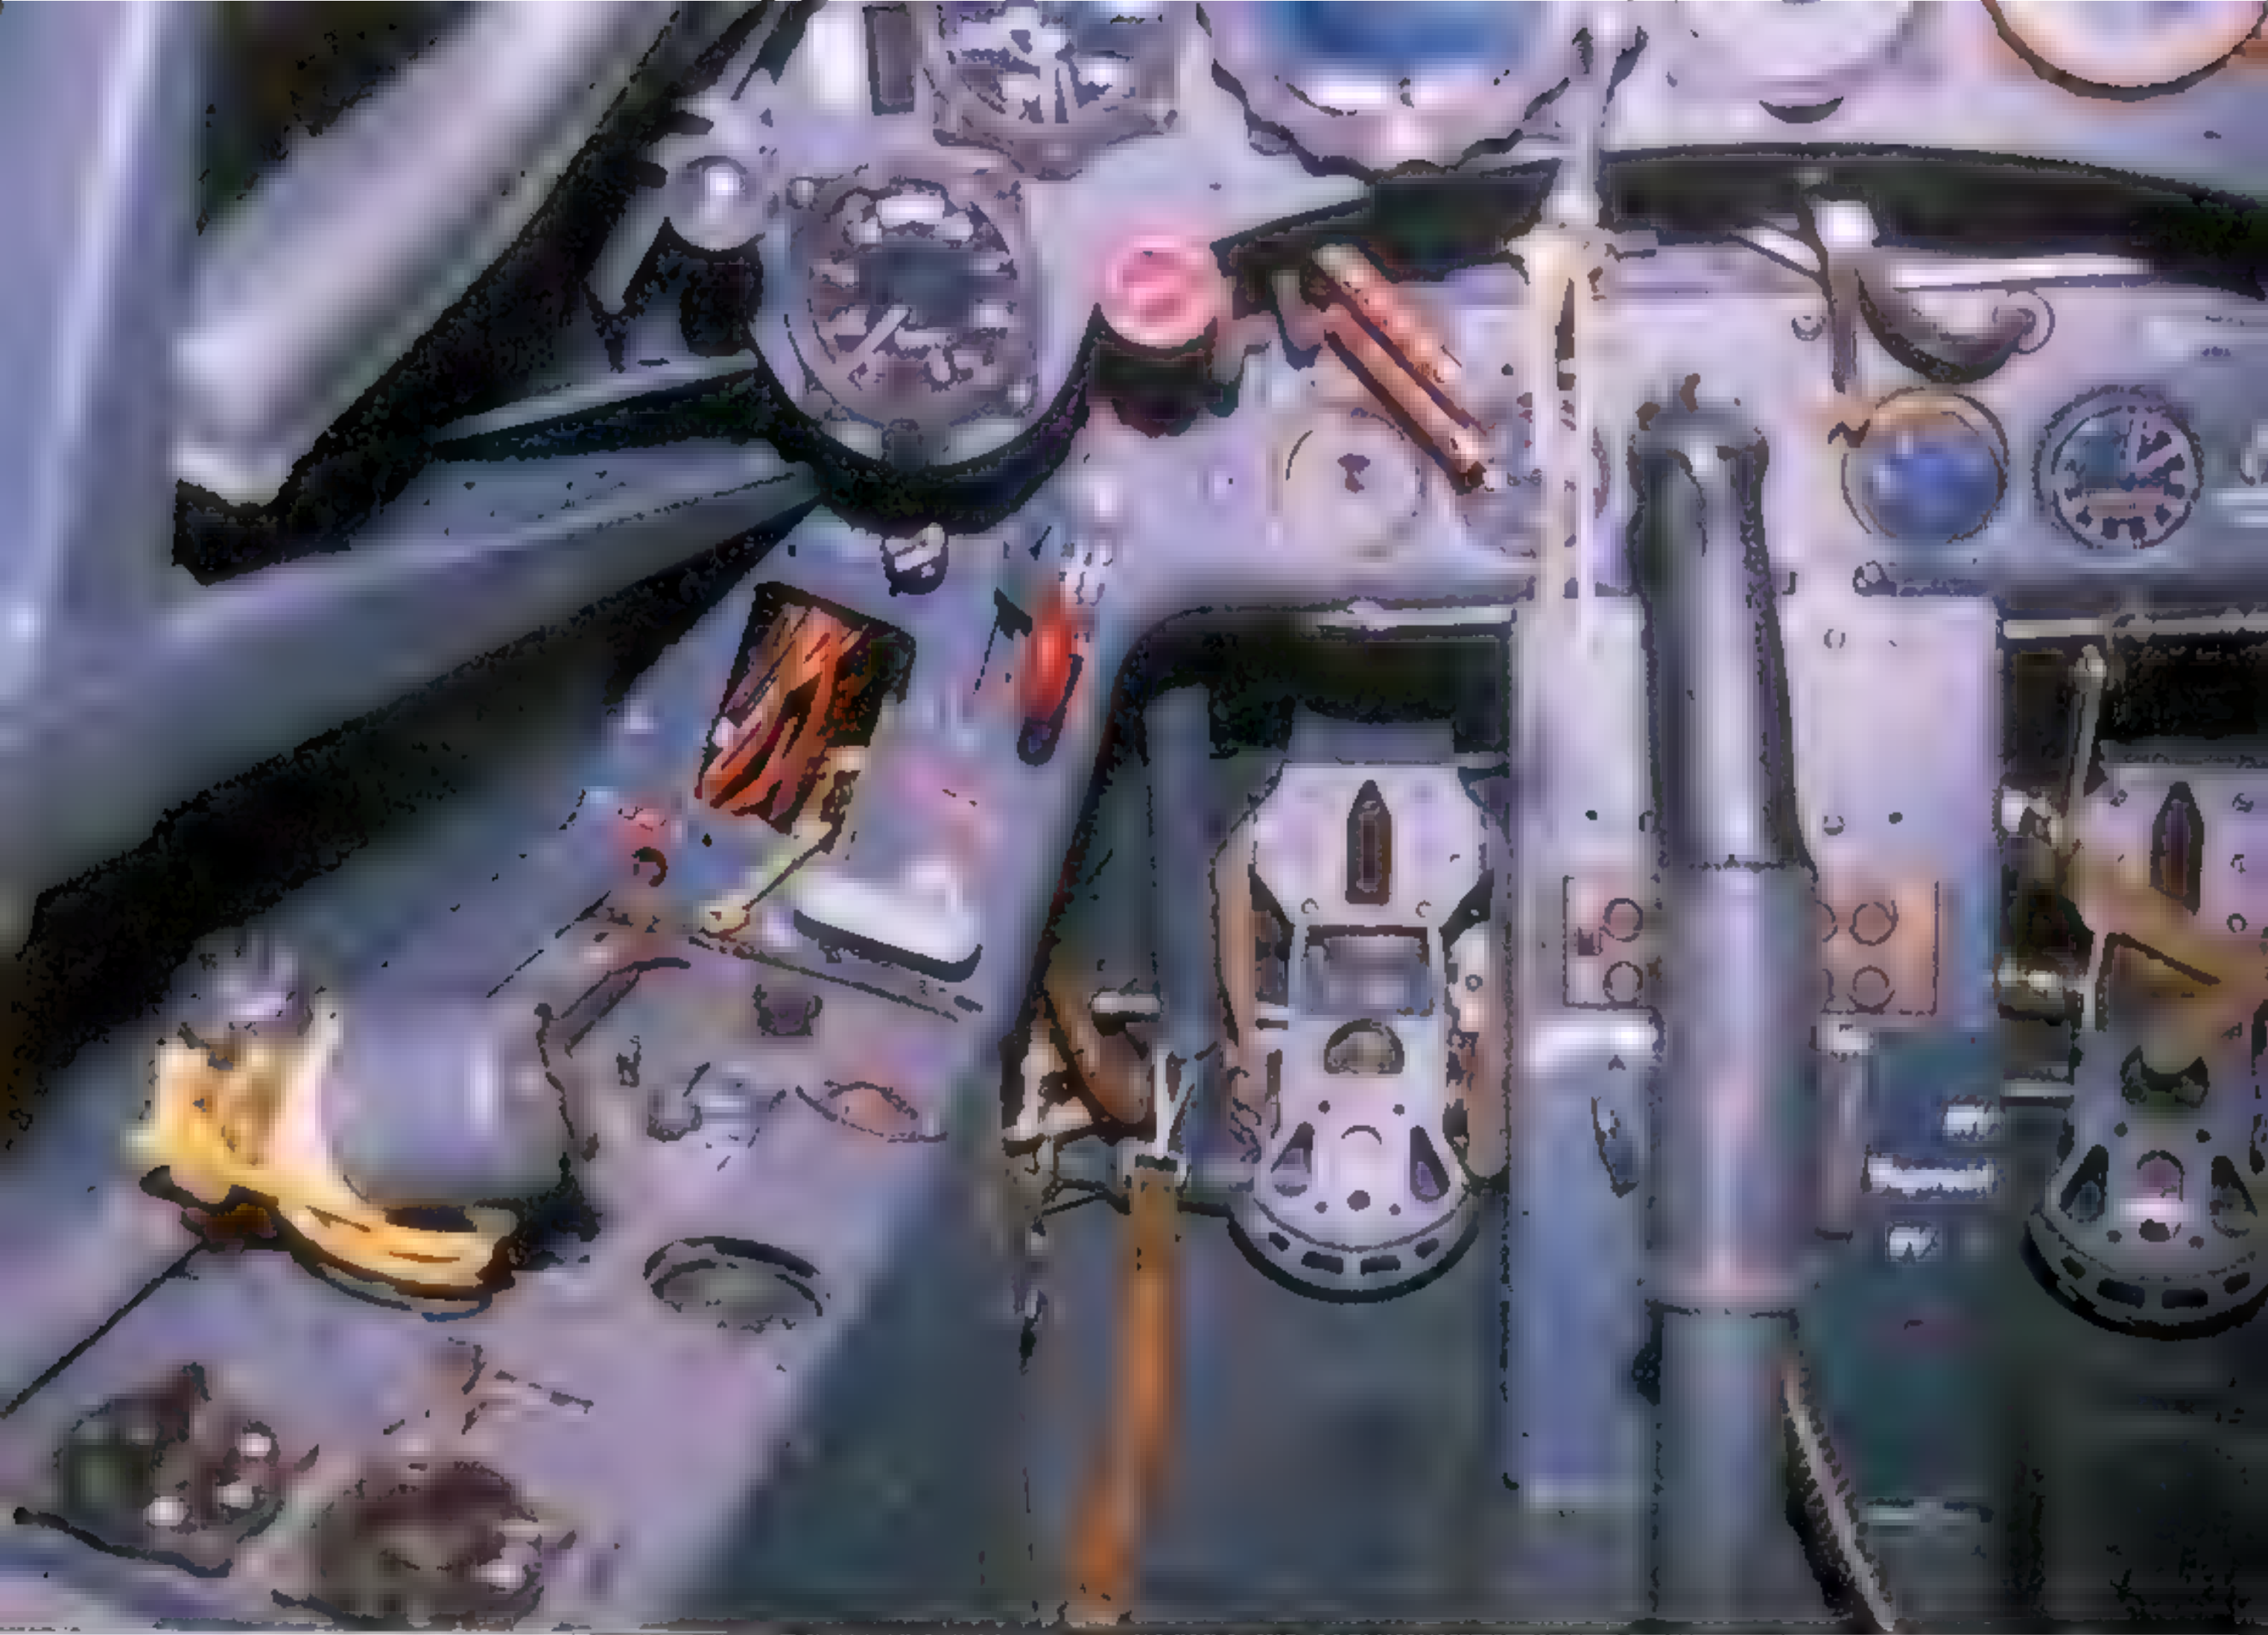
The rudder pedals hang from behind the instrument panel and have push rods attached to their outside edge. These rods proceed down the fuselage sides to the rudder differential unit, then to the rudder. The pedals have the main landing gear brake system attached to the rear sides, which is activated by toe pressure on the top of the pedals. The rudder control lock strap is attached to the left rudder pedal arm. The Fw 190F-8 armament panel is forward of the control stick. (Ryle)

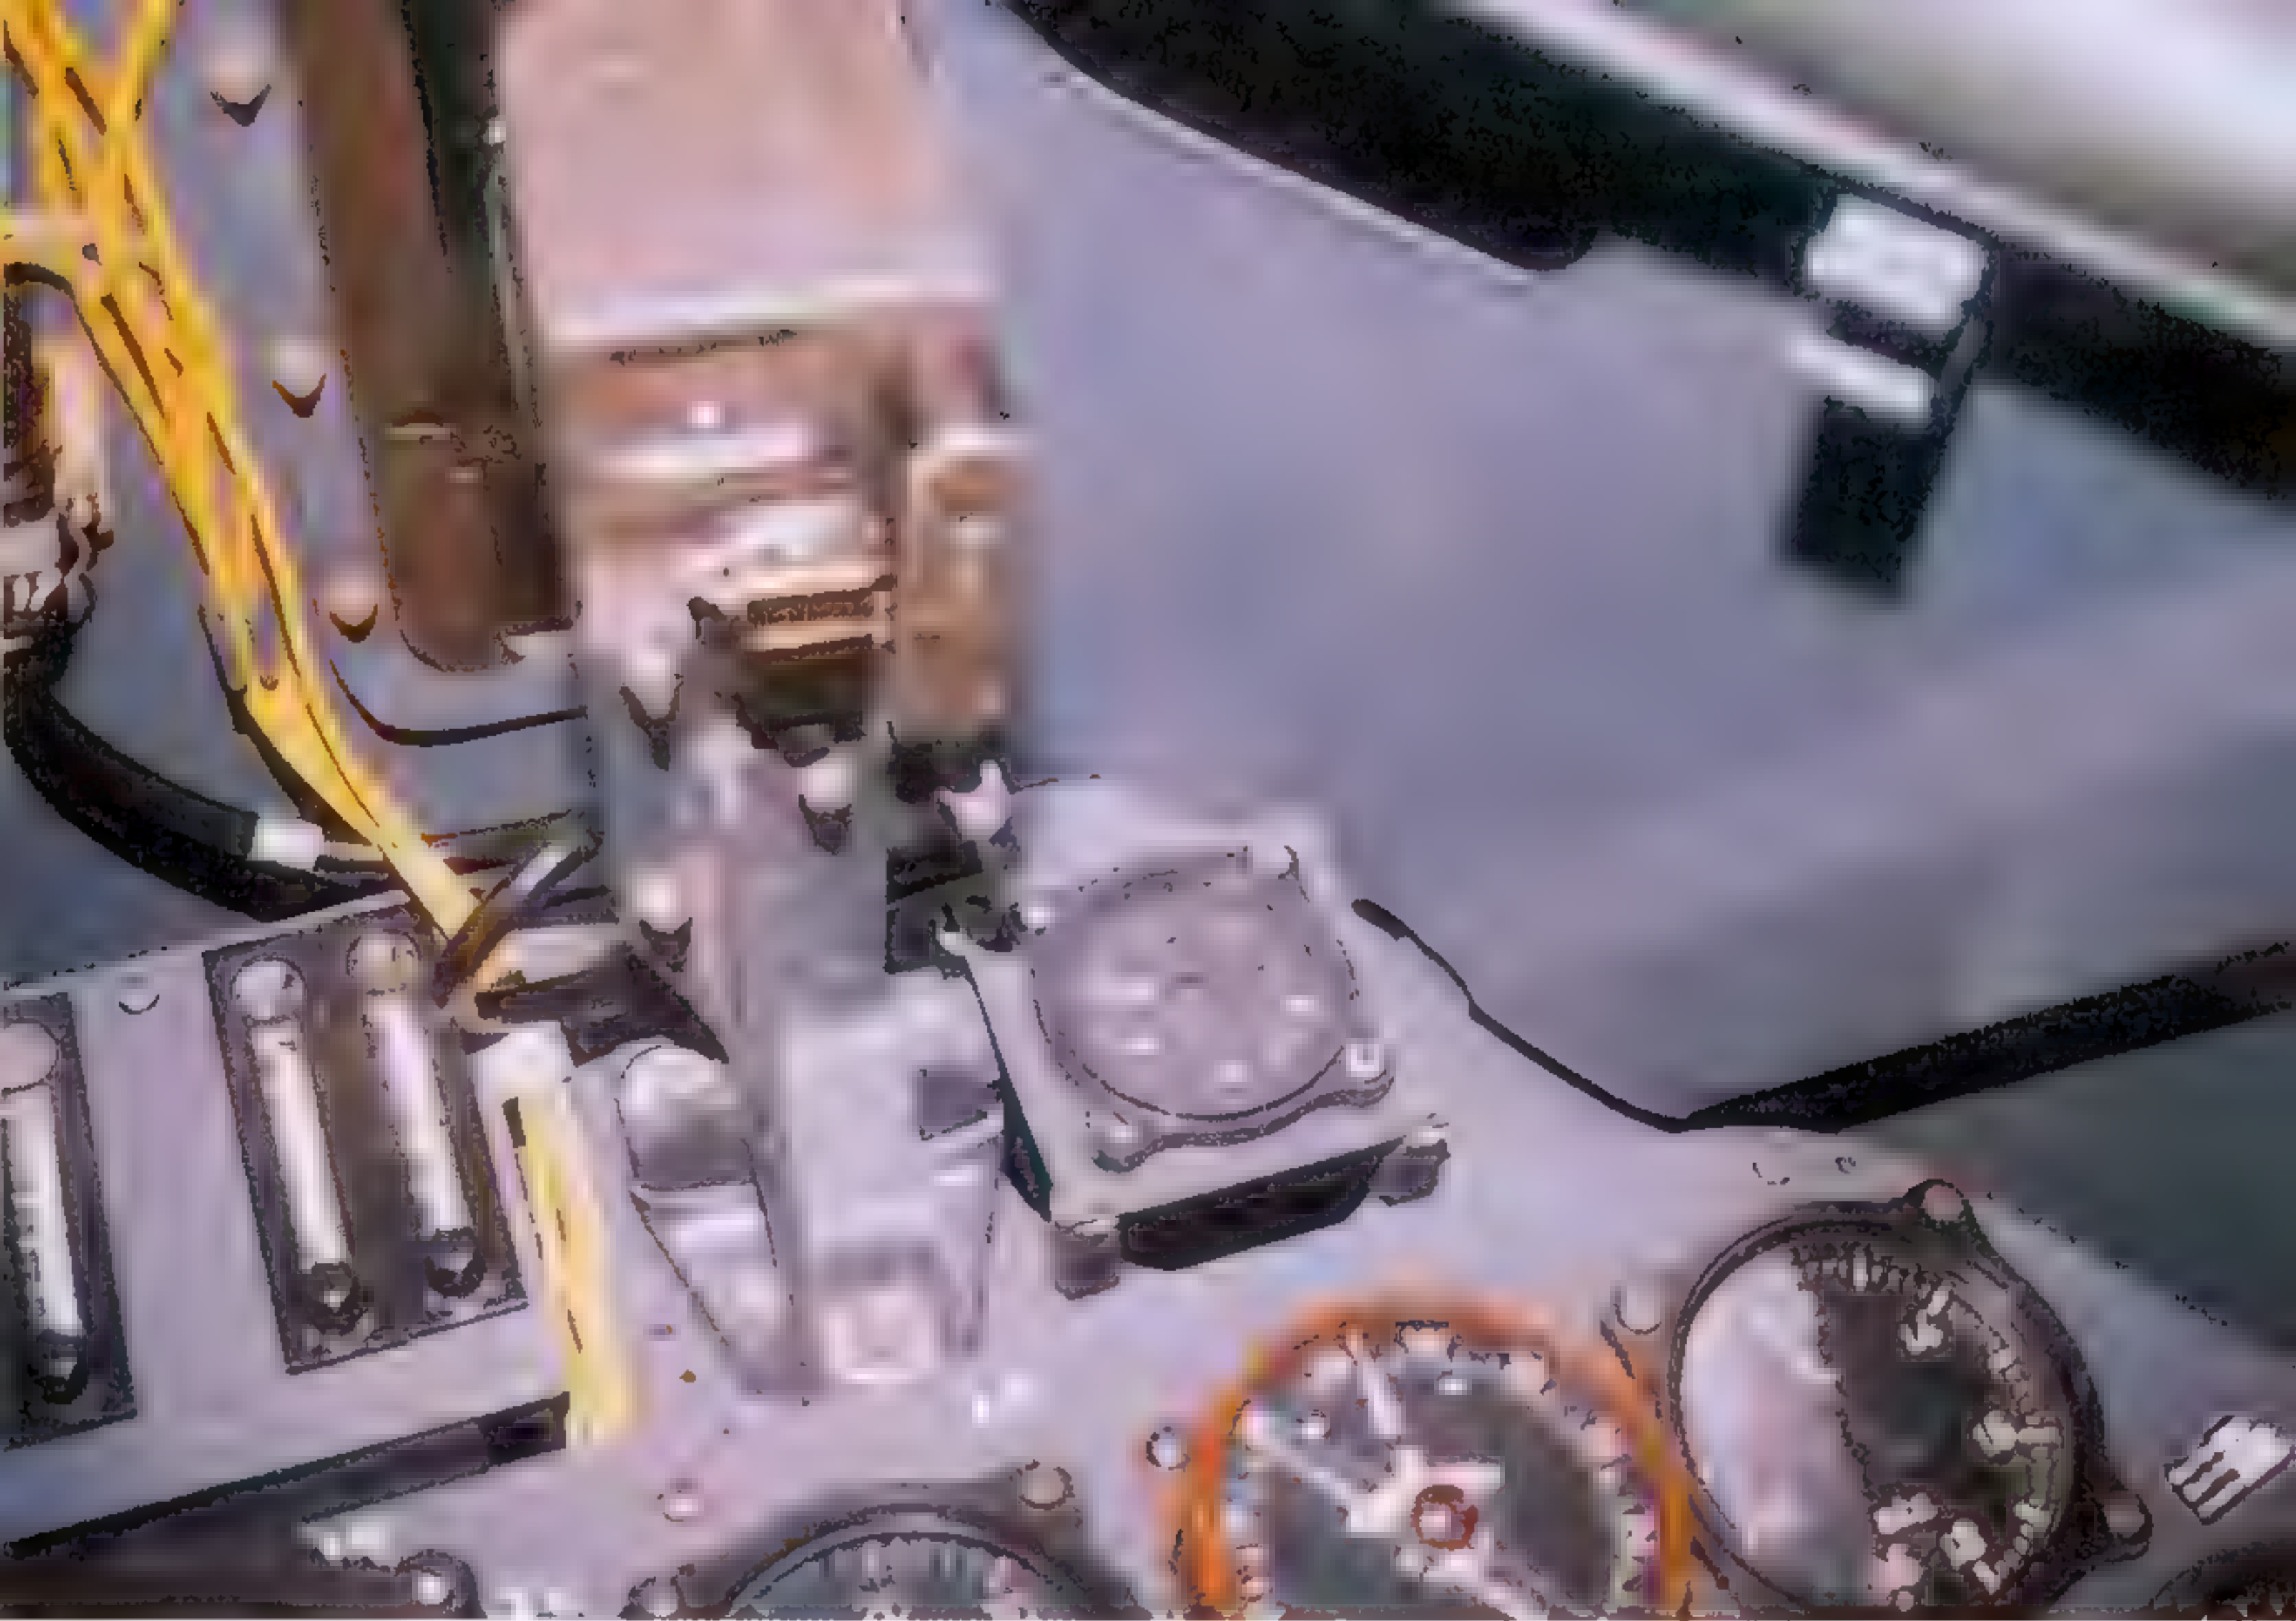
The bottom of the Revi 16B gun sight and mount is placed under the instrument glare shield. The vertical indicators to the left of the gun sight are the round counters for the cannon and machine guns, indicating to the pilot how much ammunition per gun he has remaining. The instrument to the right of the Revi mount is the FuG 16ZY homing indicator. (Ryle)

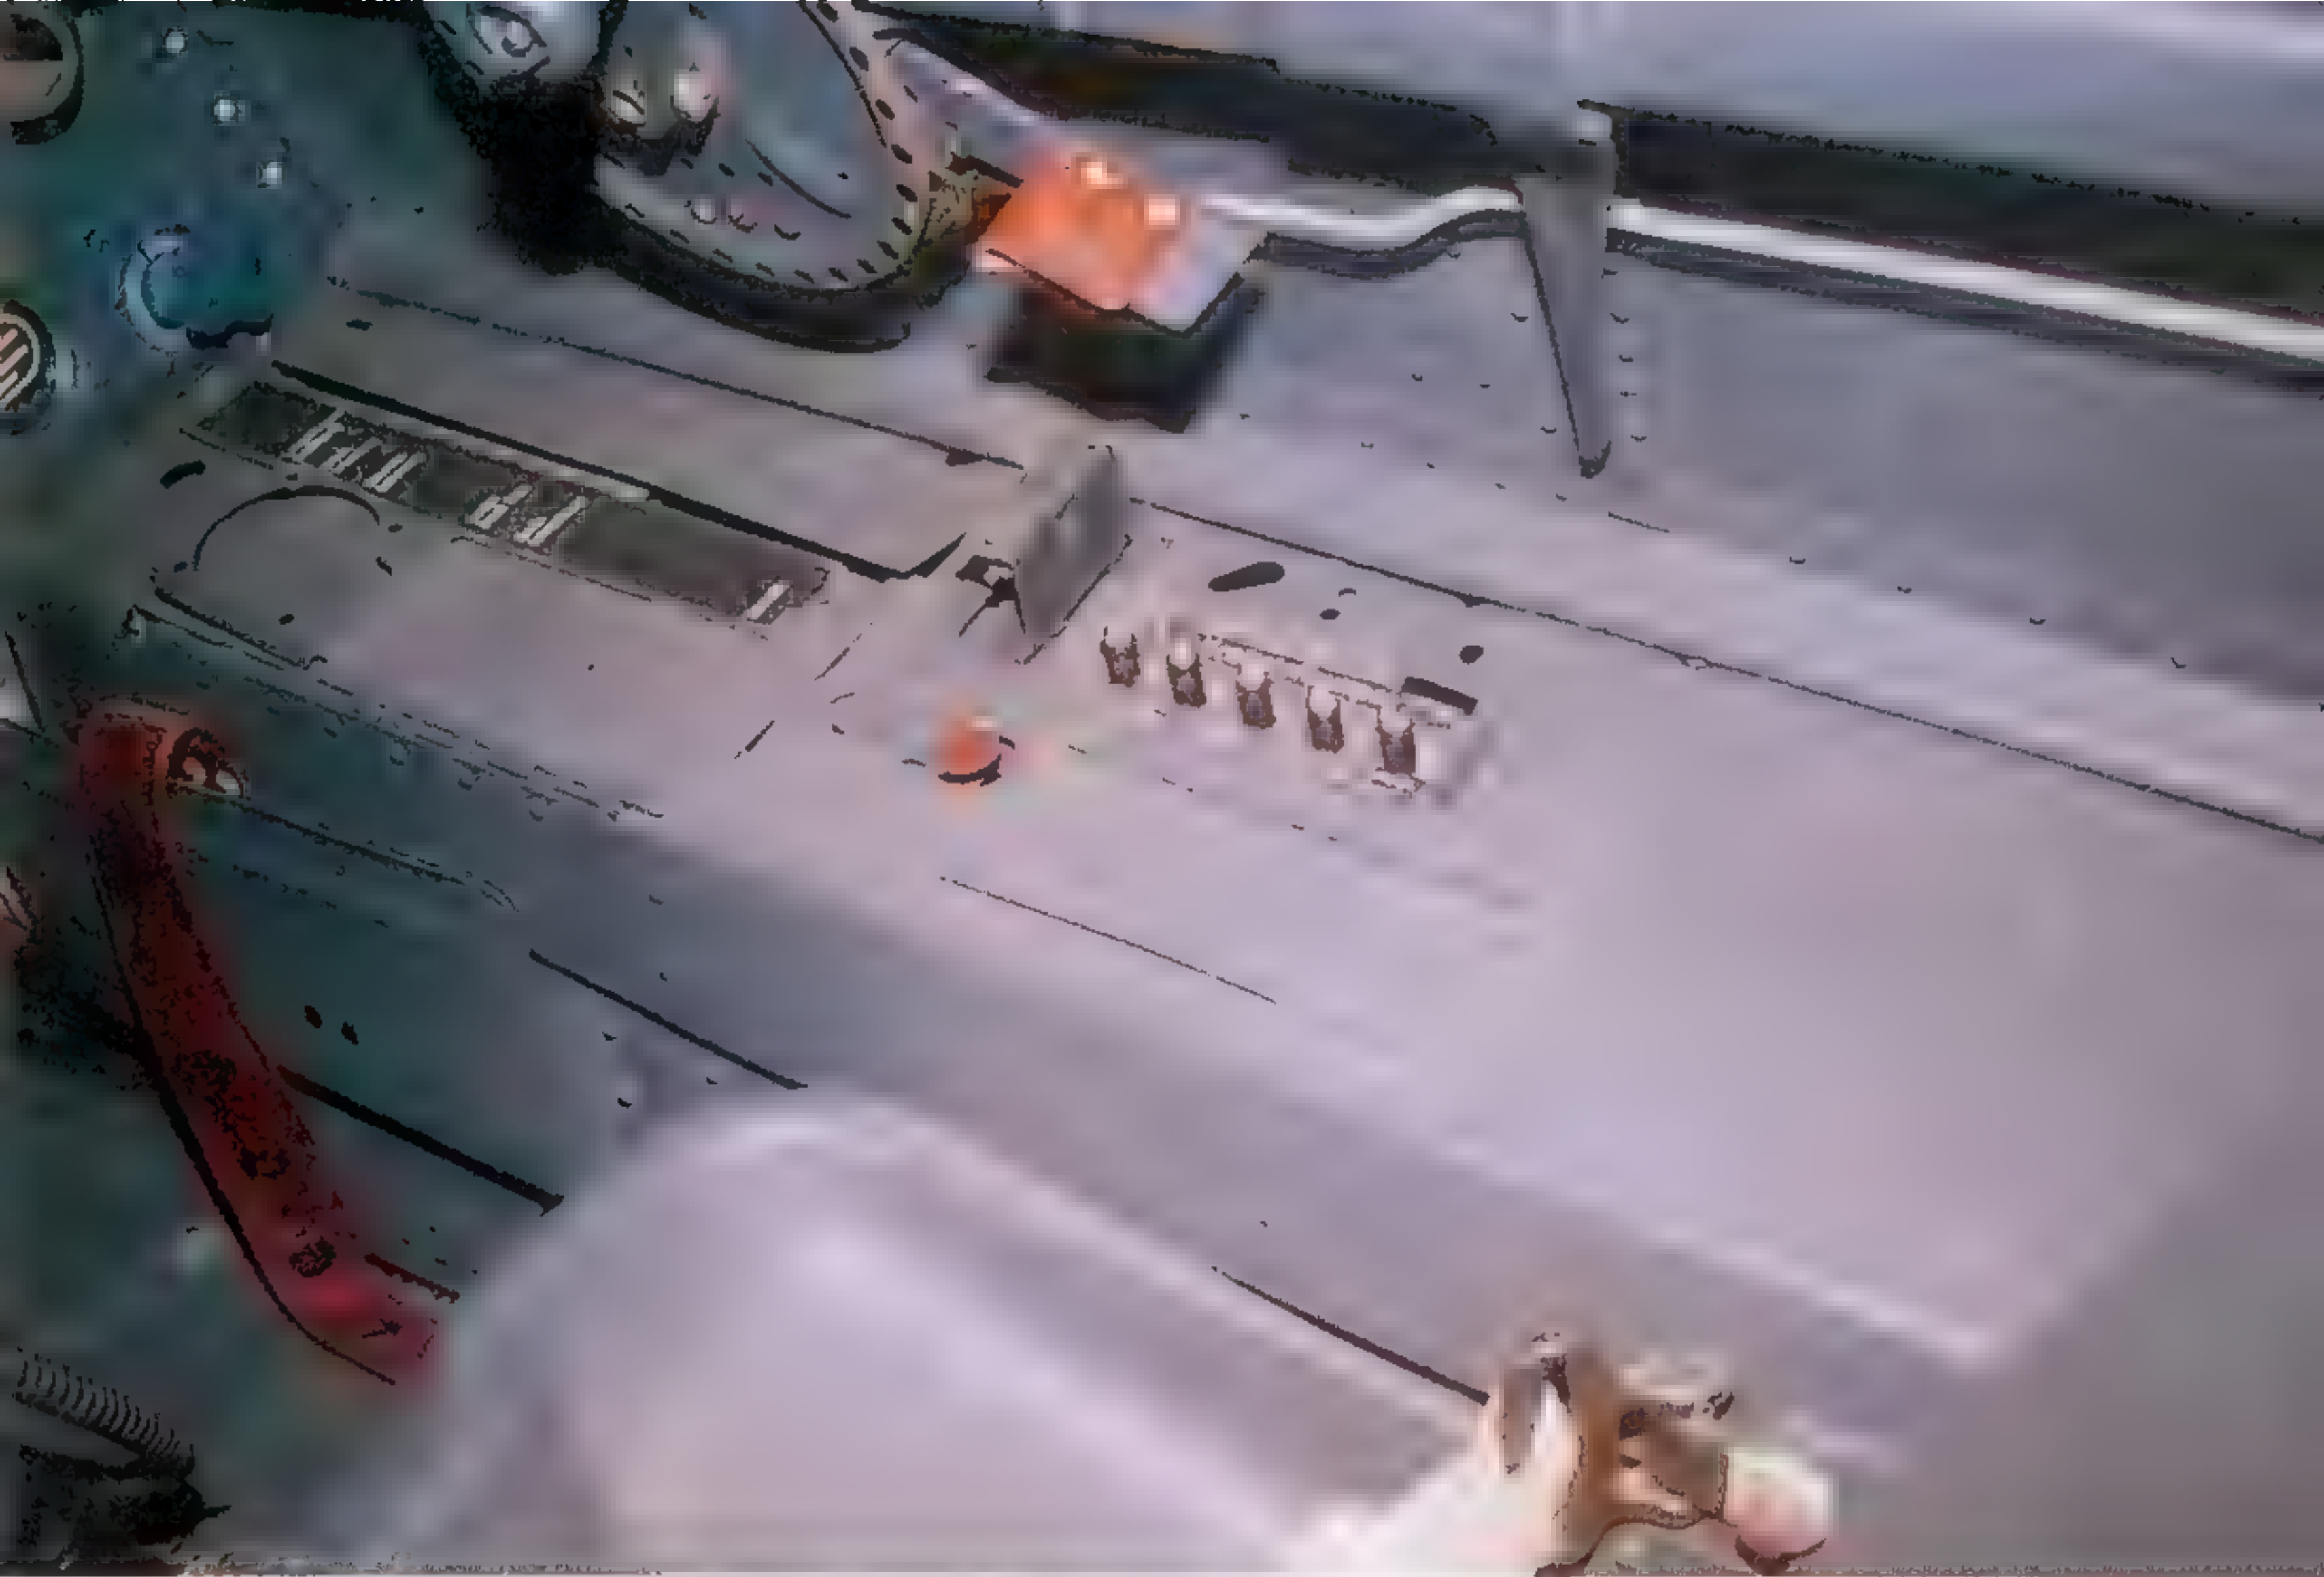
The Fw 190F-8's canopy drive crank and jettison lever are mounted above the starboard console. The silver rod along the fuselage side is the mechanical attachment to the firing pin of the explosive charge used to jettison the canopy. Console items are (from Aft): Circuit breakers; starter switch; and mount for the cockpit clock, which is missing here.
